FINAL REPORT OF INVESTIGATION

SMS 20120703 OCAT#11100

Date of Event:	July 3, 2012
Type of Event:	Train Evacuation
Incident Time:	17:49 hrs.
Location:	Between E08 and E09 – CM E1 522+00
Time and How received by SAFE:	On-Call Safety Officer
Safety Officer Response:	SAFE Rail Safety On-Call to scene/ [REDACTED]
Time of Safety Officer Arrival:	Notified 1757 hrs.; Arrived 1819 hrs.
Time of Safety Officer Departure:	2005 hrs.

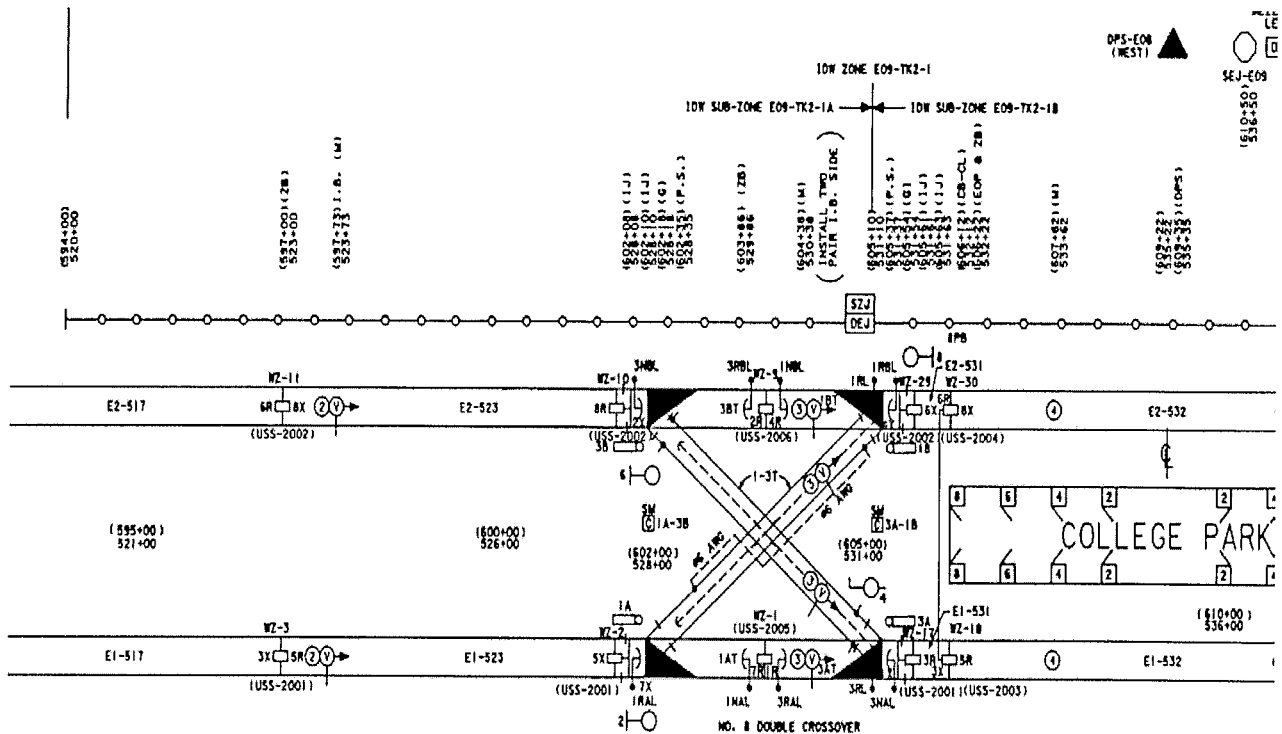
Field Sketch/Schematics

The incident site is straight Tangent track with a slight descending grade toward the College Park Station.
